# Reliability of Scanning Laser Acoustic Microscopy for Detecting Internal Voids in Structural Ceramics

Don J. Roth and George Y. Baaklini  
*Lewis Research Center*  
*Cleveland, Ohio*

Prepared for the  
Tenth Annual Conference on Composites and  
Advanced Ceramic Materials  
sponsored by the American Ceramic Society  
Cocoa Beach, Florida, January 19-22, 1986

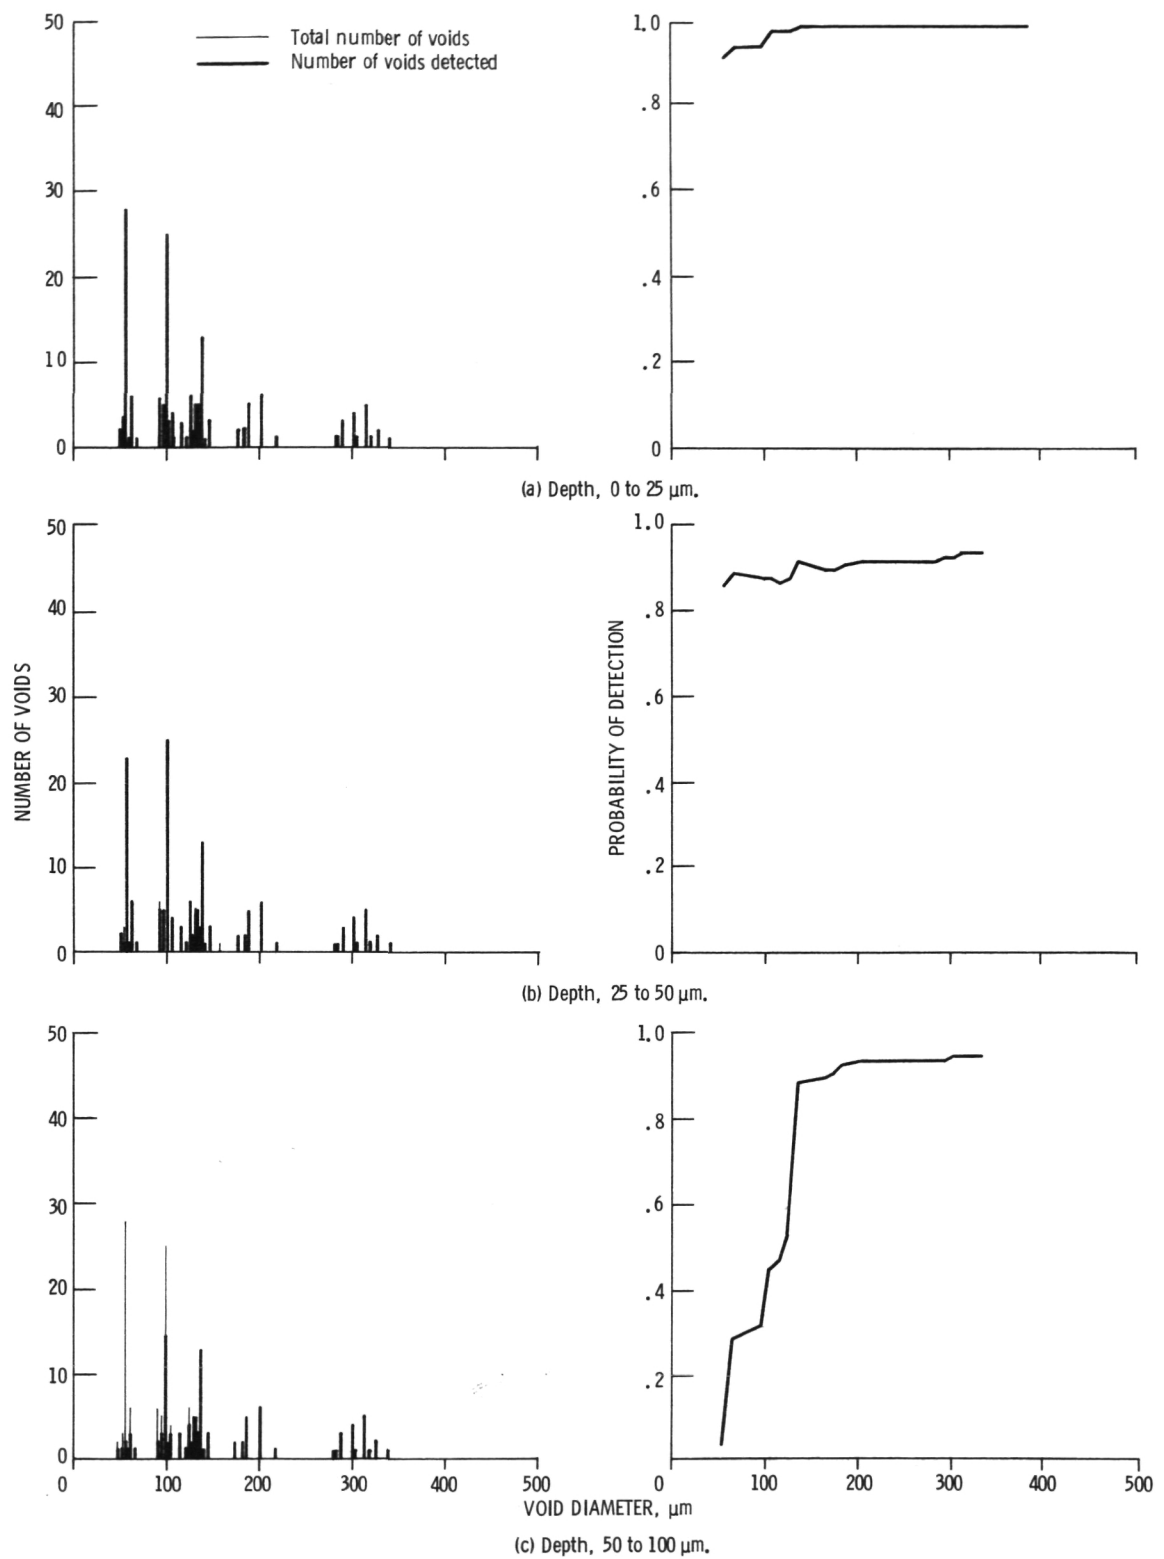
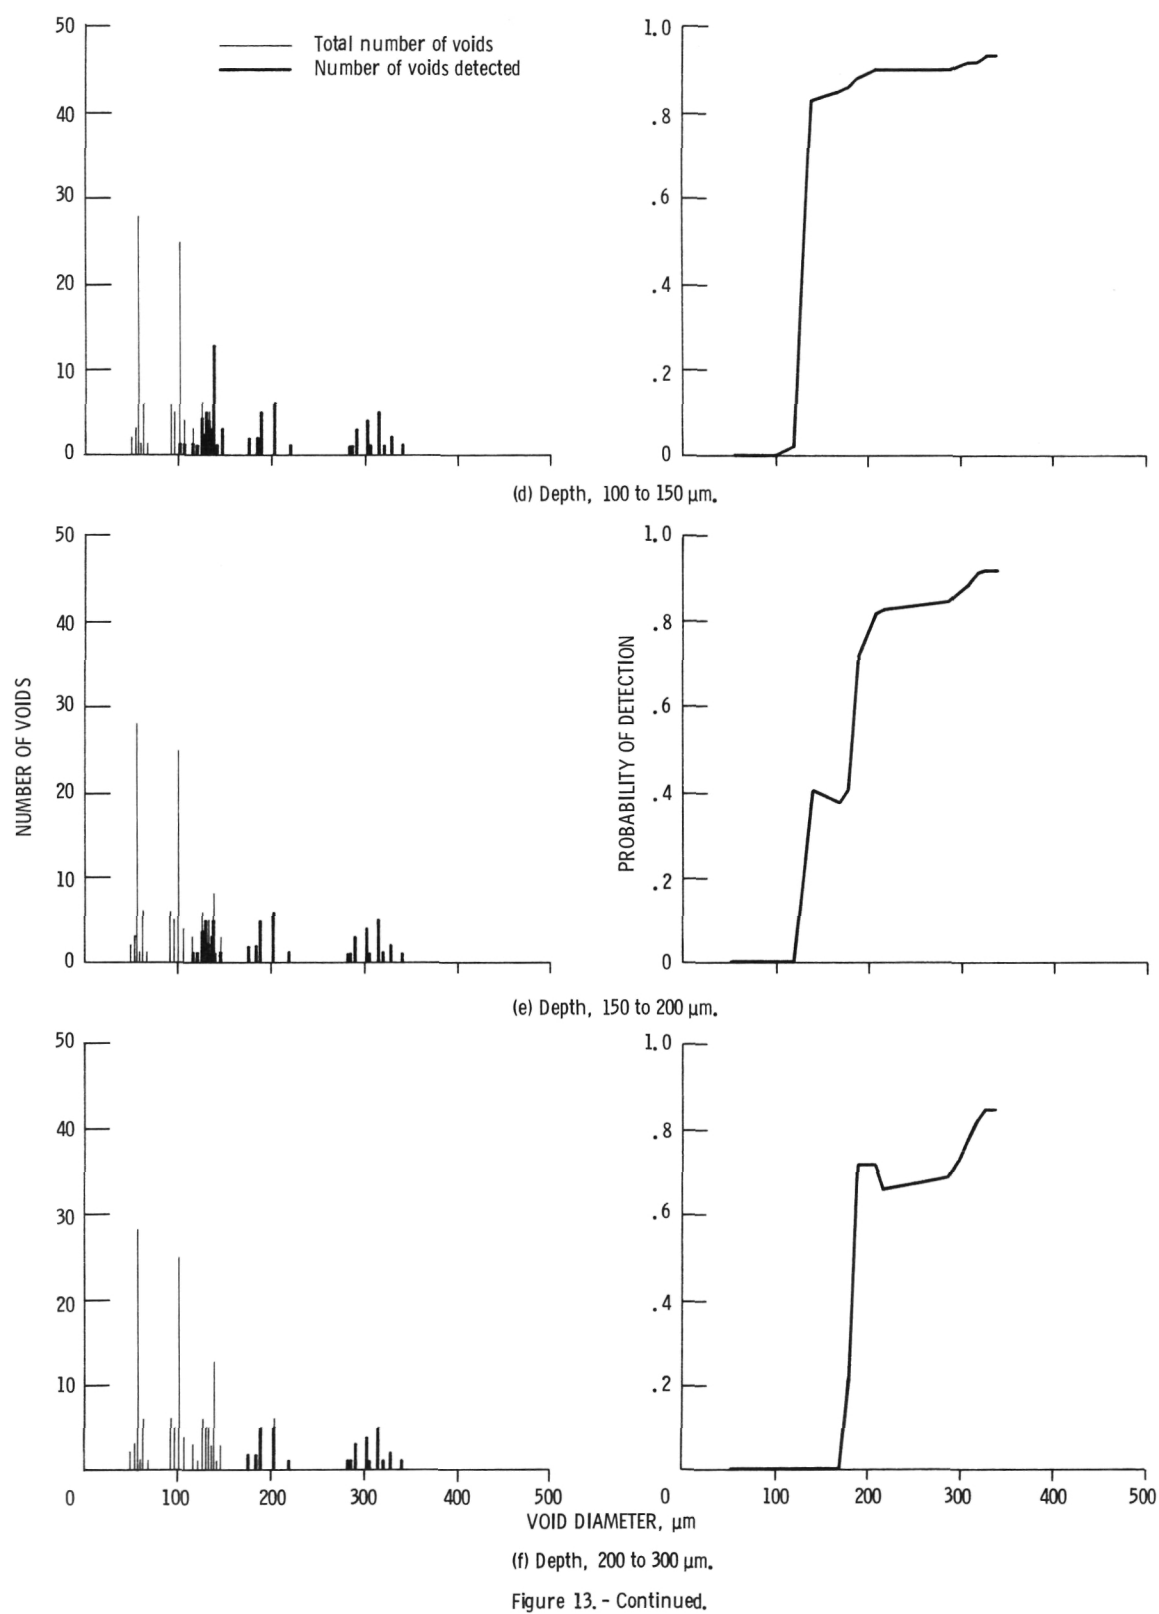
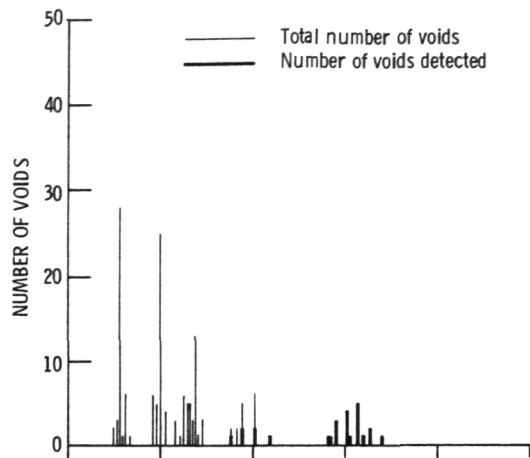
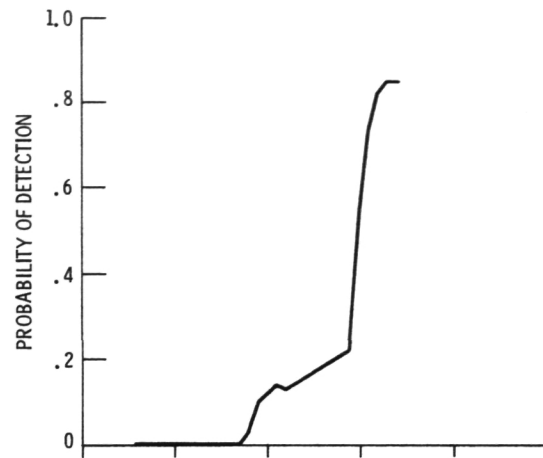
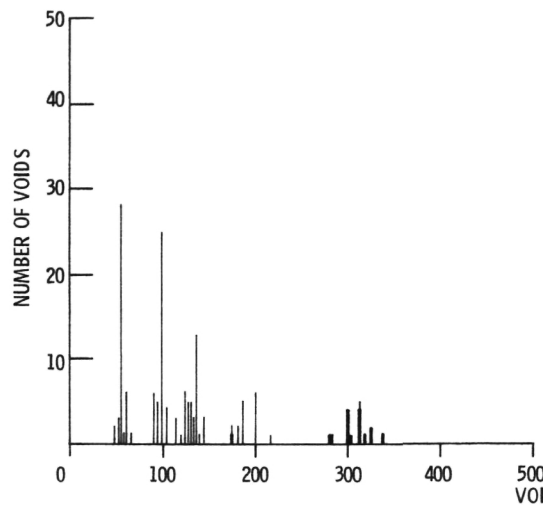
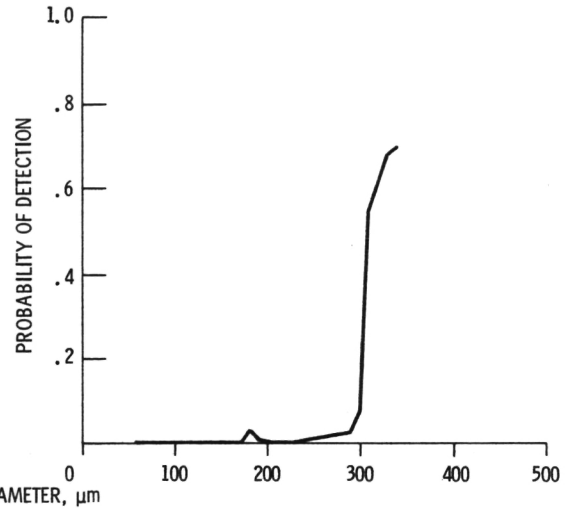
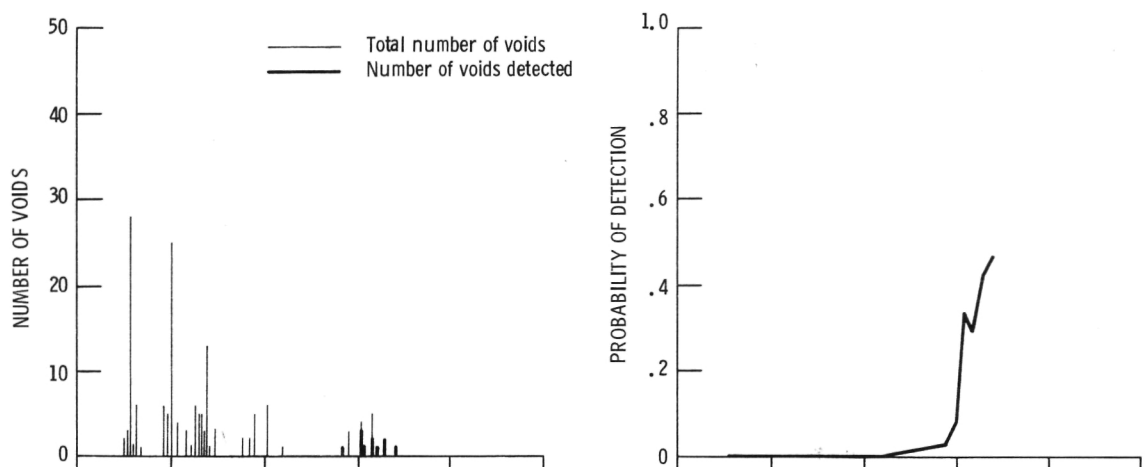
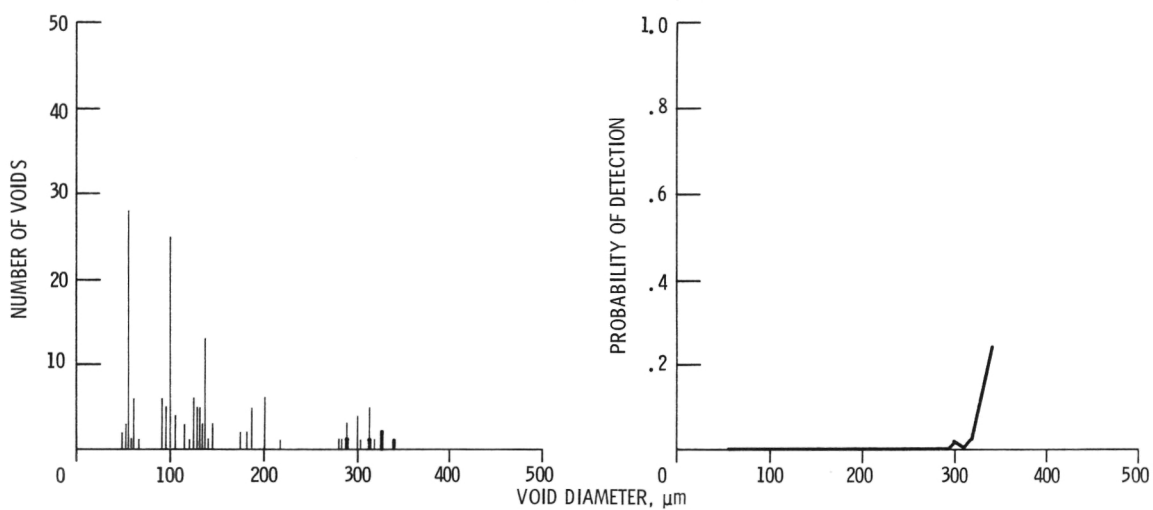
Figure 13. - Detectability data and probability of detection for seeded voids positioned below laser-scanned surface in sintered silicon carbide specimens. Probability calculated at 0.95 confidence level.

Detectability data and corresponding probability of detection curves at each depth range for the seeded internal voids in sintered silicon carbide appear in figures 13(a) to (j).
